Full-Scale Testing of Thermoplastic Composite I-Beams for Bridges

Ghassan K. Al-Chaar, Steven C. Sweeney, Richard G. Lampo,
and Marion L. Banko

June 2017

Final report

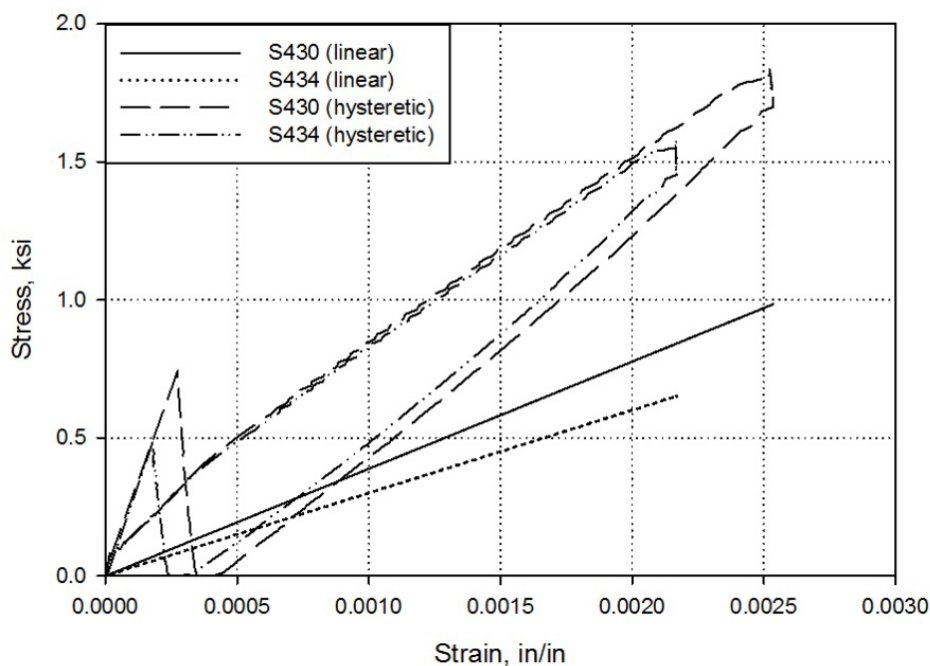
The first two entries in Figure 76 show stress-strain curves at S_{430} and S_{434} , based solely on strain readings and the thermoplastic material's Young's moduli from mechanical property tests. The final two entries in Figure 76 are hysteretic stress-strain loops determined from the estimated location of the neutral axis, section properties, and point load magnitudes.

Figure 76. Two approximations of stress-strain curves at S_{430} and S_{434} .

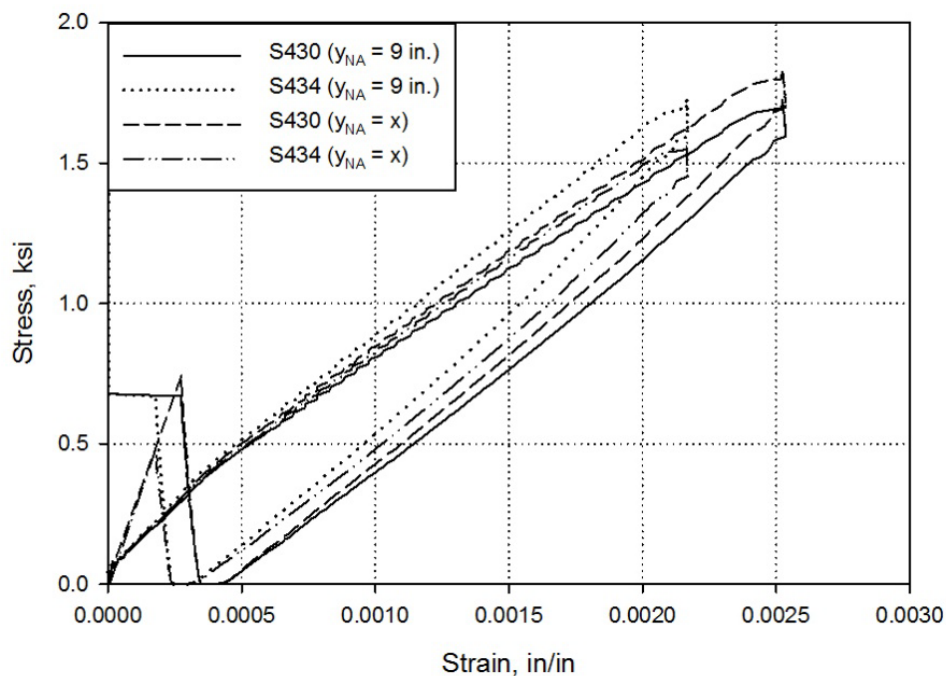
Figure 77 shows the hysteretic loops from Figure 76 with stress-strain curves approximated as in the other tests (assuming the neutral axis to be at the midsection height). The results of the two approaches are reasonably close, showing maximum values within 10% of one another. The assumption that the beam's neutral axis occurs at the section midheight

Figure 77. Two approximations of stress-strain curves at S_{430} and S_{434} assuming neutral axis at mid-height.

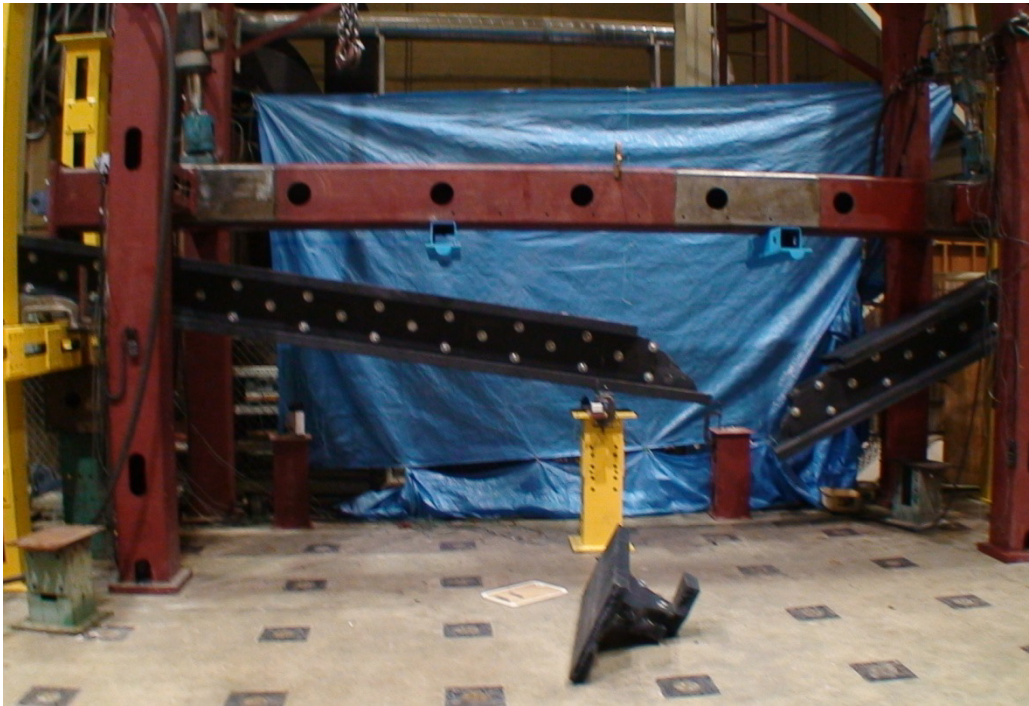
Figure 78. Specimen after failure, with broken section on floor.

Photos depicting the failure of this specimen are shown in Figure 78–Figure 82.

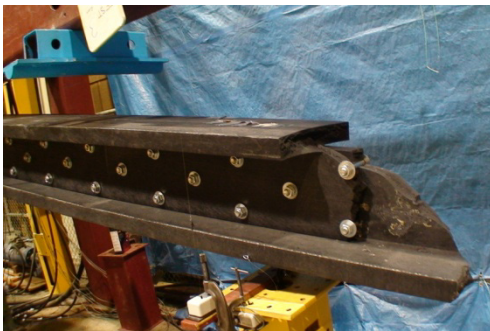
Figure 79. Delamination between webs.

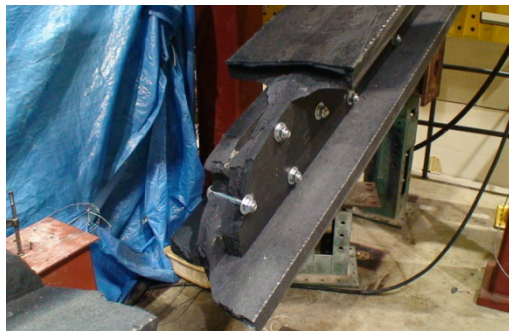
Figure 80. Crack through bolt hole and between flange and web.

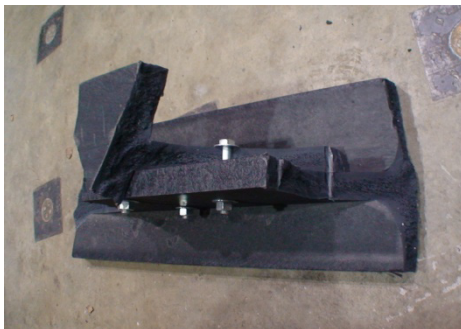
Figure 81. Broken section, top view.

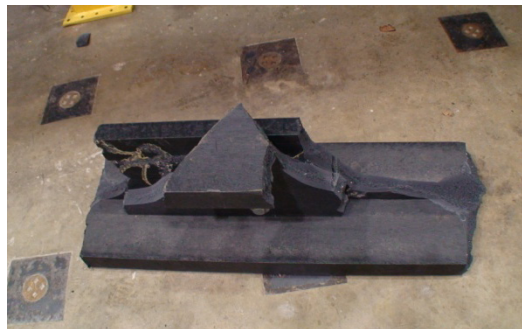
Figure 82. Broken section, west side.

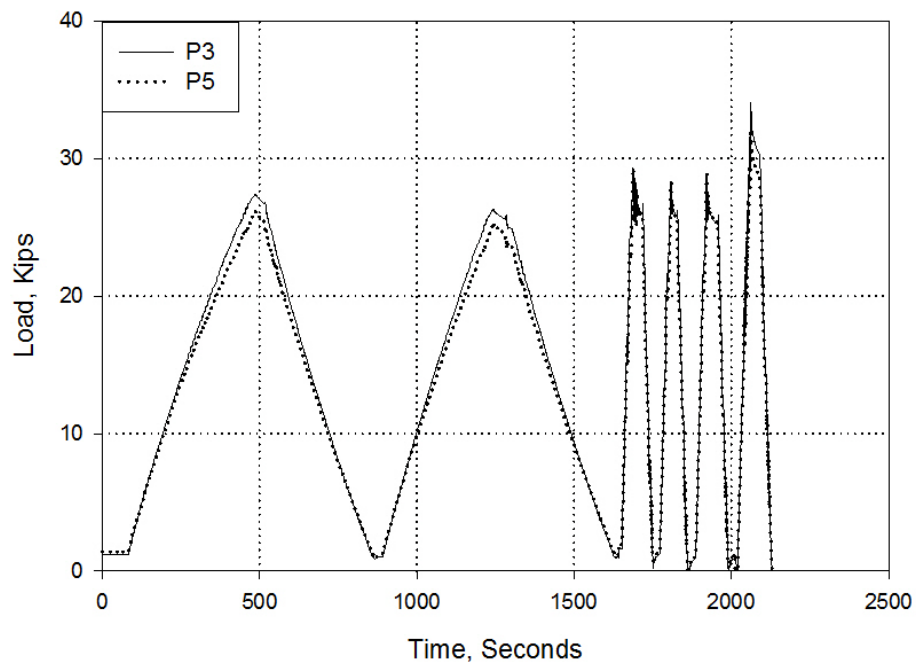
Figure 87. Time-variation of point loads, final four cycles.

The force applied by each actuator is plotted versus time in Figure 86 and Figure 87. Note the trend of a larger maximum force at higher loading rates, and the apparent force decay over the hold time at each peak displacement. Force decay over time is also apparent in the nonlinearity of

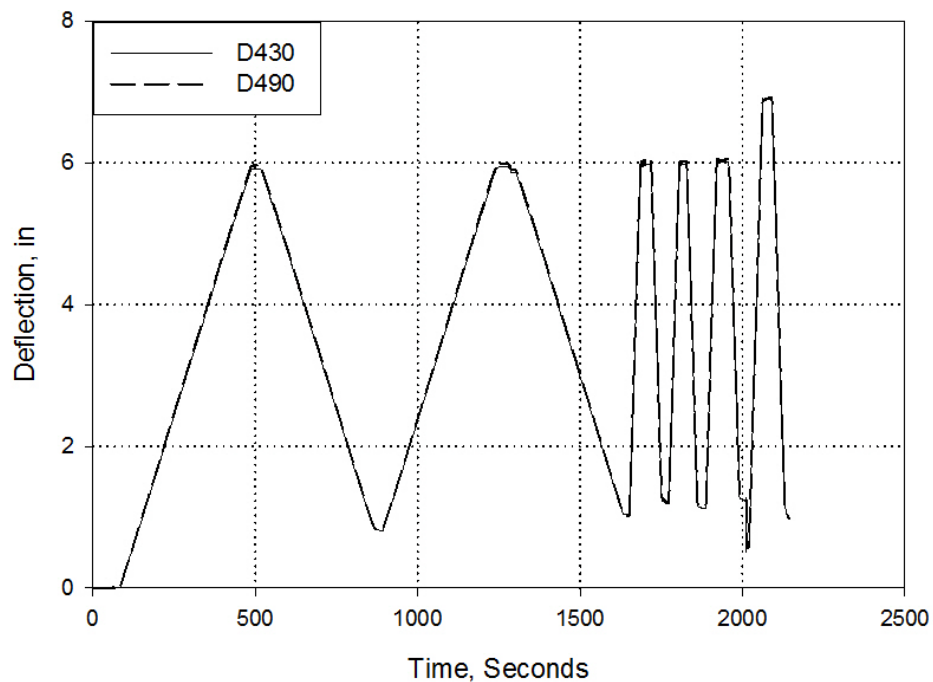
Figure 91. Displacement over time at midspan bottom fiber, final four cycles.

The corresponding displacements over time at midspan are shown in Figure 90 and Figure 91. Residual deformation also appears in this location after removing the load.

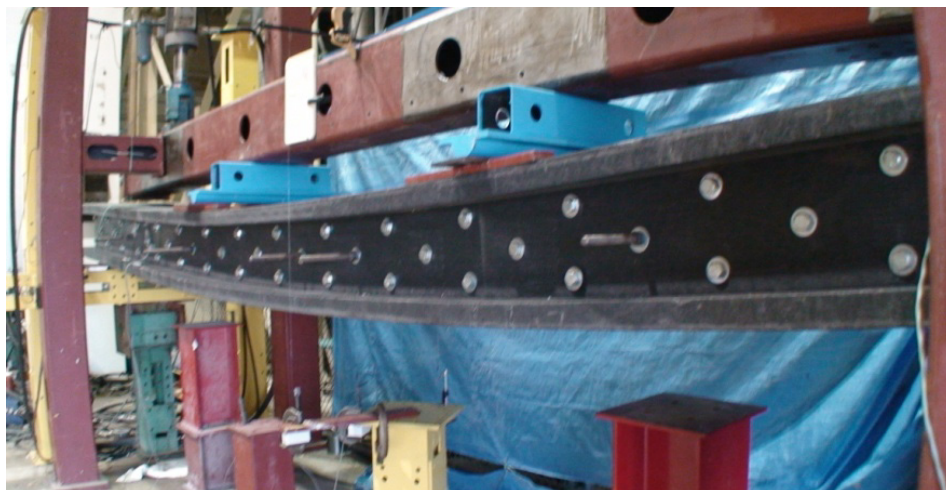
Figure 102. Excessive deformation without failure.

No developing failure modes or even visible cracks were observed in the specimen during loading. The maximum midspan deflection of the specimen was about 7 in. for a 270-inch span. The corresponding deflection-to-span length ratio is about 1:38, which is well beyond the allowable range for use in bridges and other structures. Therefore, the design of this span would generally be controlled by deformation rather than strength for this type of loading. Excessive deformation is shown in Figure 102.

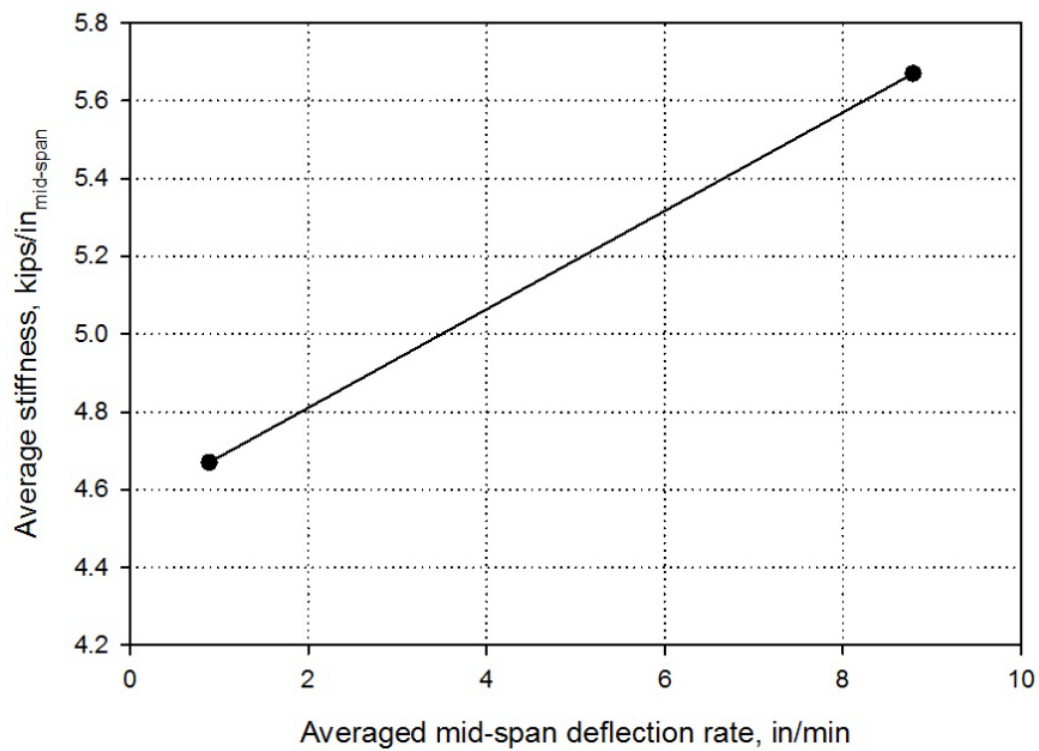
Figure 104. Effect of average midspan deflection rate on average specimen stiffness.

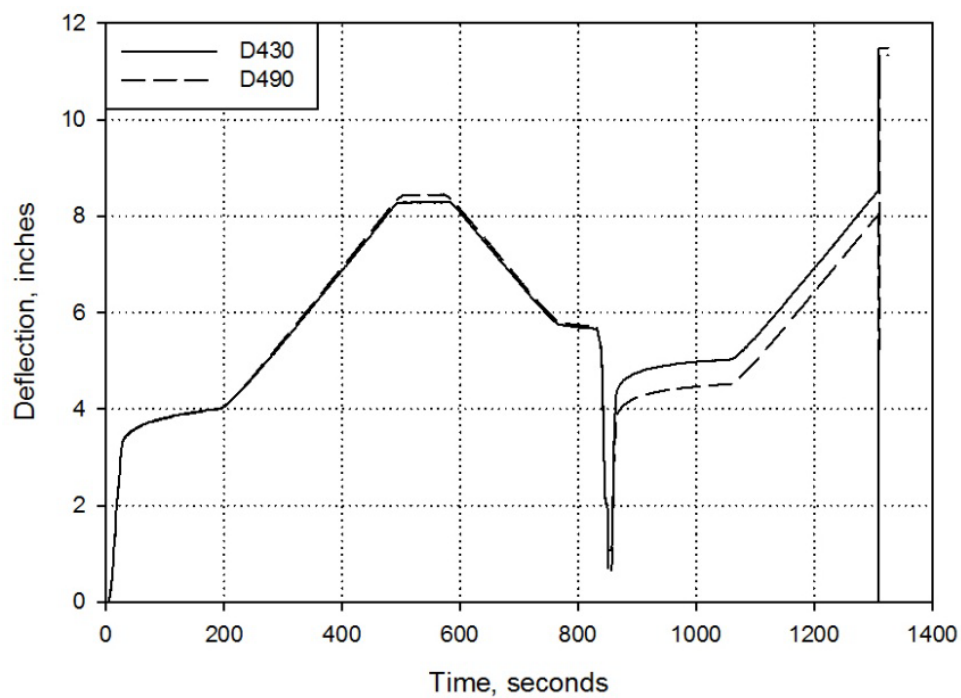
Figure 111. Midspan displacement under both loading actions.

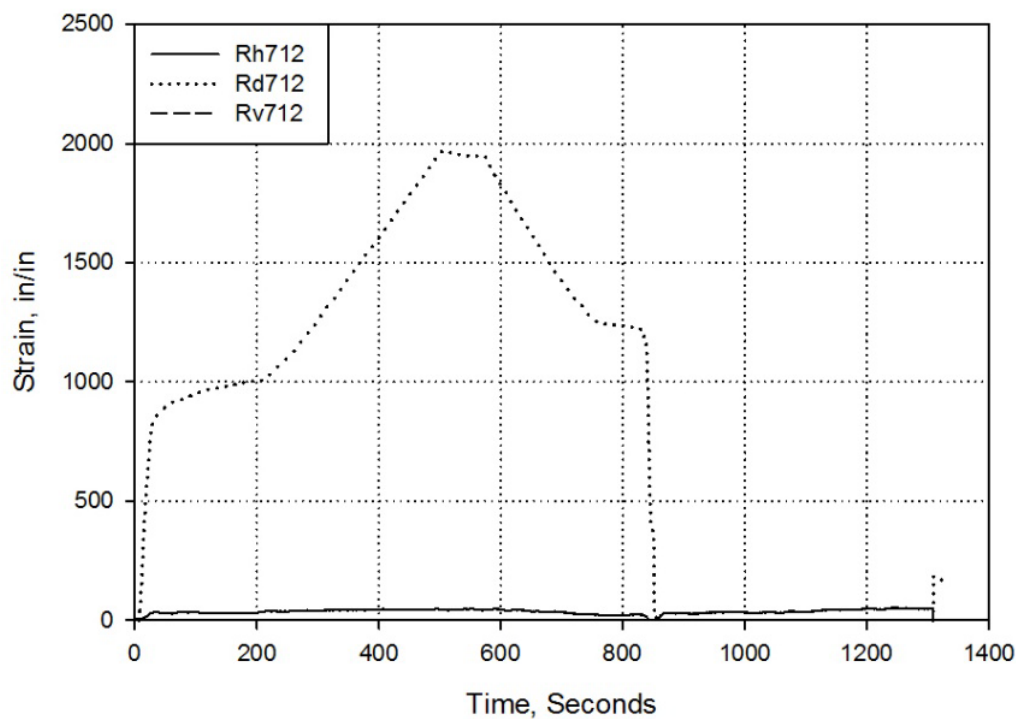
Figure 115. Strain values measured by the rosette R₇₁₂.

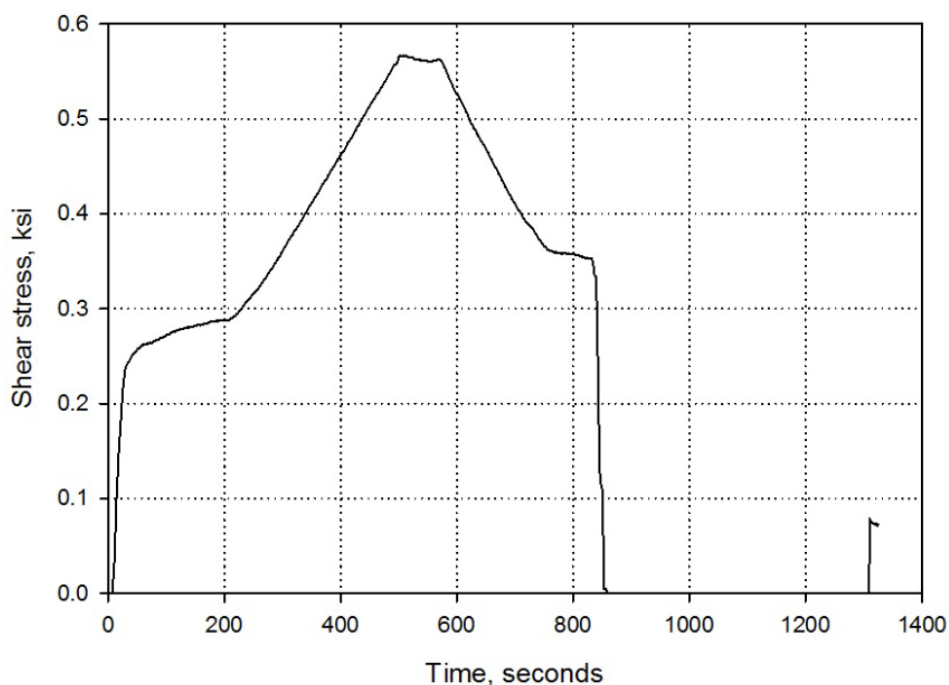
Figure 117. Actuator point load P_5 versus calculated shear stresses at R_{712} .

The shear stress at gauge rosette R_{712} can be *approximated* by using measured rosette strains and the material properties which were determined from mechanical testing. The calculated stresses are plotted against time in Figure 116, against measured P_5 in Figure 117, and against *approximated* P_5 in Figure 118. It is important to note that the specimen is neither linear nor elastic, and it displays some behavior similar to a viscous fluid (deflection rate-dependent force generation and time-dependent deflection under constant force). Therefore, the accuracy of shear stresses calculated from measured strains is uncertain. Below the horizontal dashed line denoted as “Border” in Figure 118, it is evident that the approximated loading curve from Figure 118 may not be a very accurate representation of the actual preloading procedure, but it does serve to provide the proper y-axis offset.

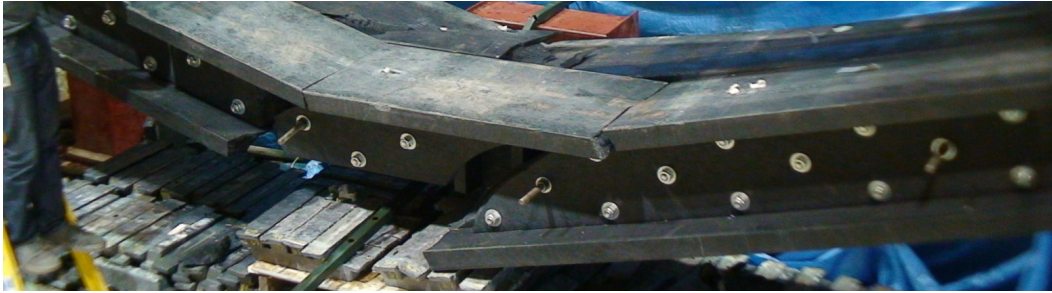
Figure 122. Oblique view of specimen, cracks in top flange are visible.

Figure 121–Figure 124 show several views of the failure that was initiated between the two actuators in the region of approximately constant flexural stress. One crack appears to have initiated in the bottom flange and then propagated diagonally through the web and top flange. The other crack initiated in the bottom flange and continued vertically part-way through the web before splitting into a “Y-crack” and entering the top flange, with one branch of the Y-crack passing through a bolt hole. Other cracks did not show a tendency to pass through bolt holes.

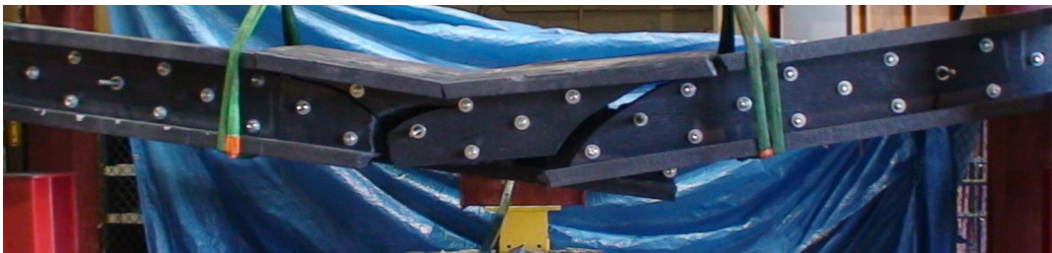
Figure 123. Cracks in the web.

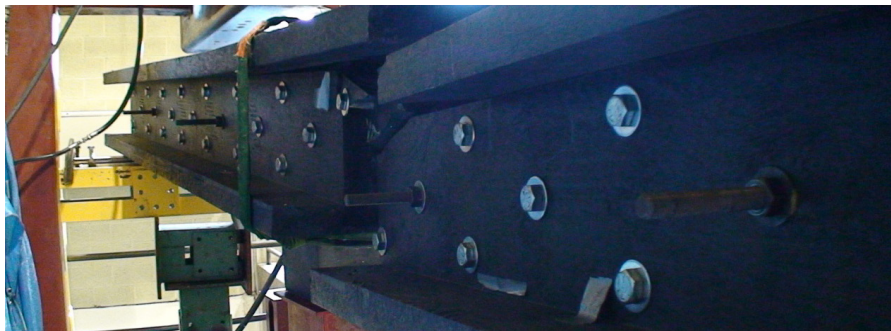
Figure 124. Longitudinal view, looking north.

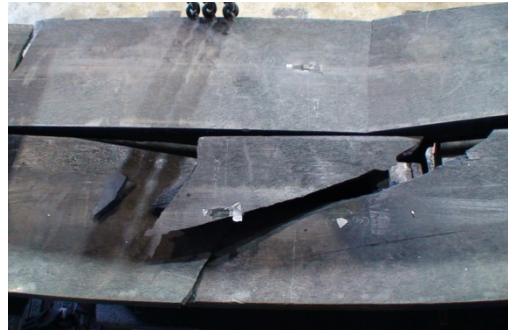
Figure 126. Cracks in the top flange.

More photos depicting the brittle failure of this specimen are presented below. Figure 125 shows web-flange delaminating, Figure 126 shows cracks in the top flange,

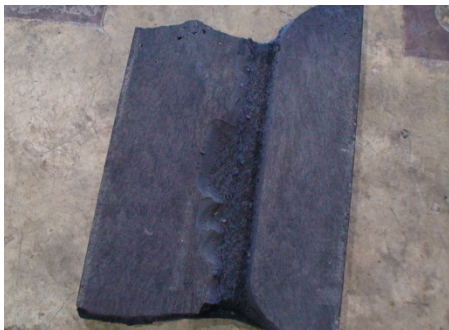
Figure 127. Separation surface between flange and web, shown on flange.

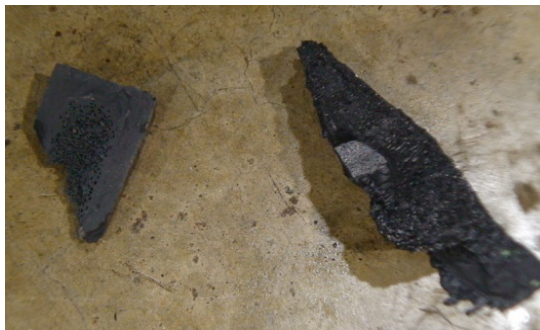
Figure 128. Fragments that became airborne due to brittle failure.

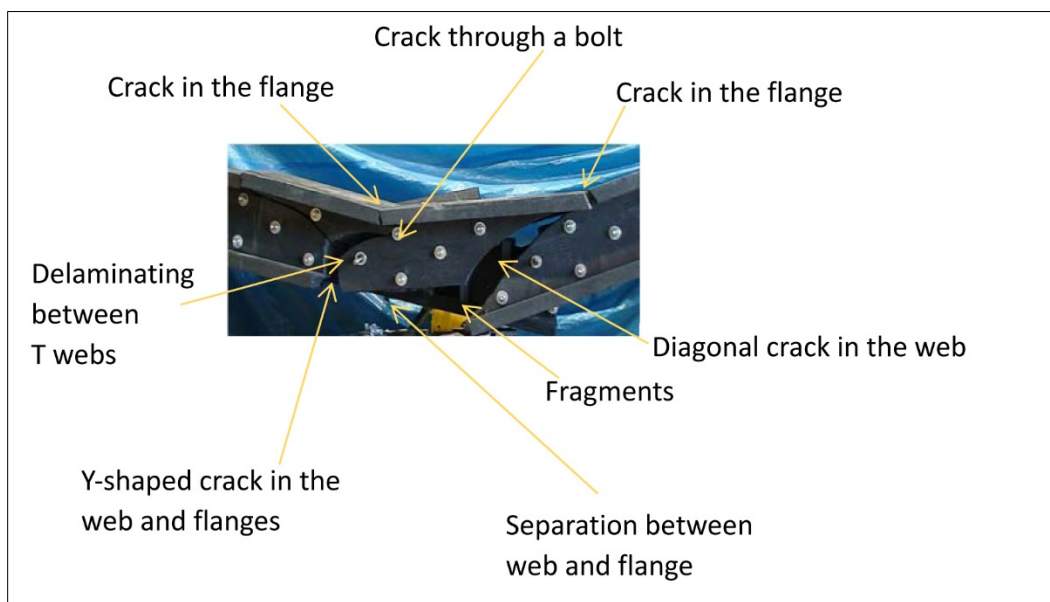
A summary of the significant cracks in the middle section is shown in Figure 129.

Figure 129. Crack survey.
